Halton District School Board

Addendum No. 1

RFT 21-257 Interior Renovations – Joseph Gibbons PS

REVISED PRE-RENOVATION DESIGNATED SUBSTANCES AND HAZARDOUS MATERIALS SURVEY

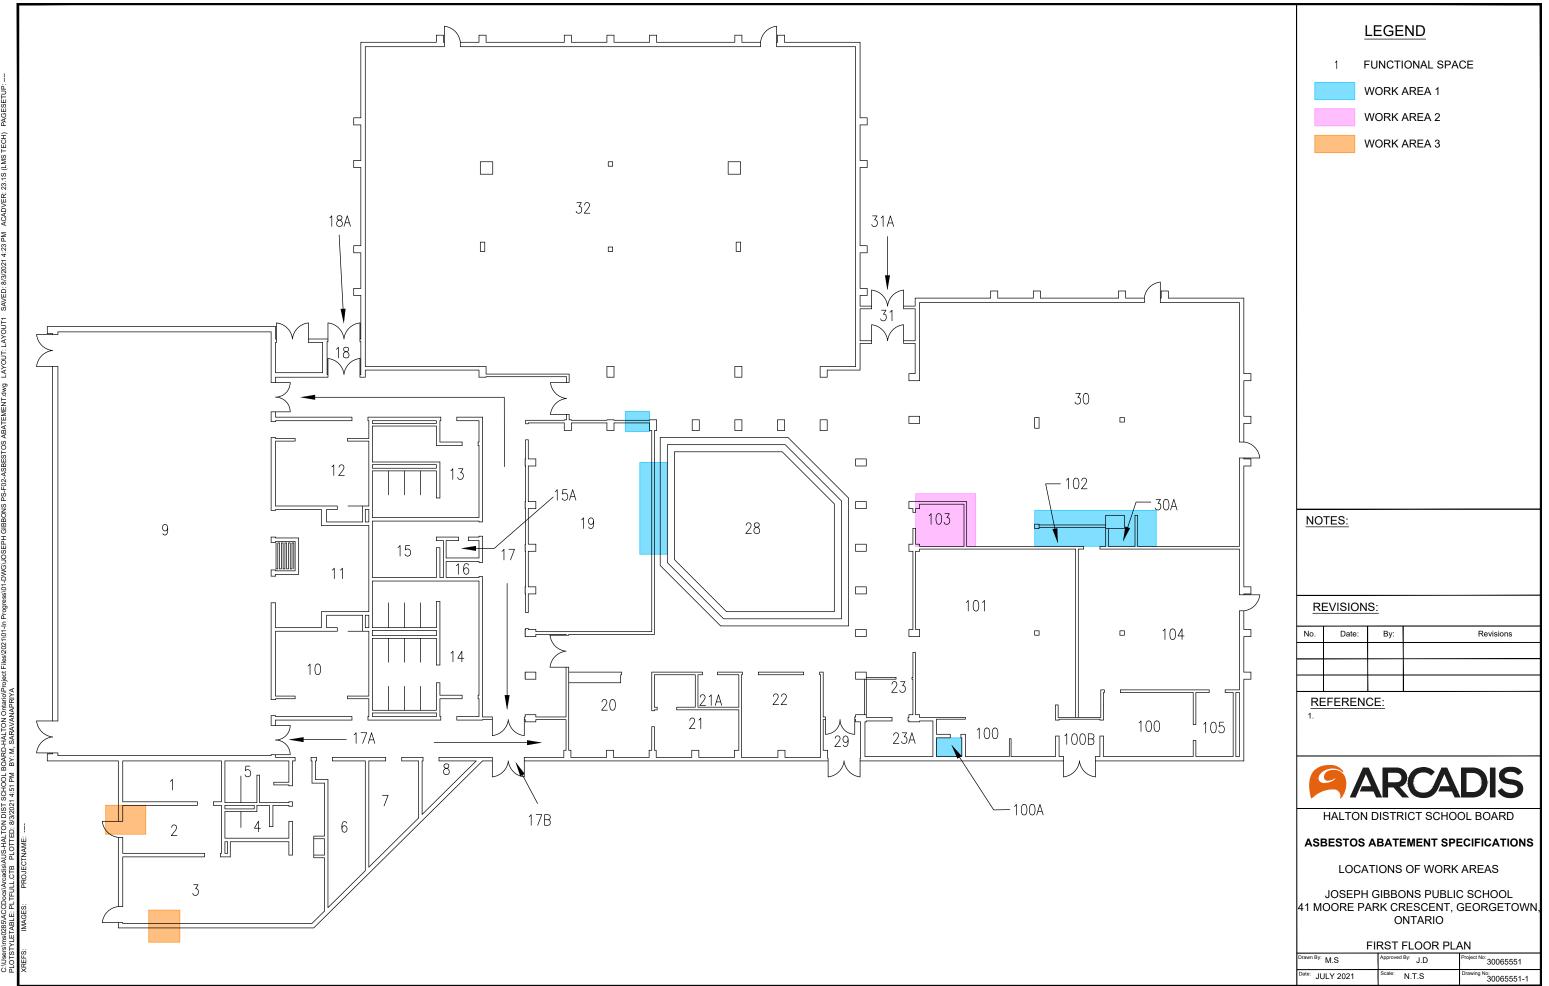
Drawing No. 30065551-1 - Locations of Work Areas - First Floor Plan

.10 Work Area 1 - Rooms19, 28, 30, 30A, 32, 100A and 102

.11 Work Area 2 - Rooms 103 and 30

.12 Work Area 3 - Rooms 2 and 3 and Adjacent Outdoor Areas
